**Analysis of Costs for the Operation and
Maintenance of the Transportation Related
Areas of New London Union Station, the
Adjacent Greyhound Facility and the Water
Street Parking Garage**

**Southeastern Connecticut
Council of Governments**

**As an Addendum to the Regional Intermodal
Transportation Center Master Plan and
Efficiency Study**

November 2010

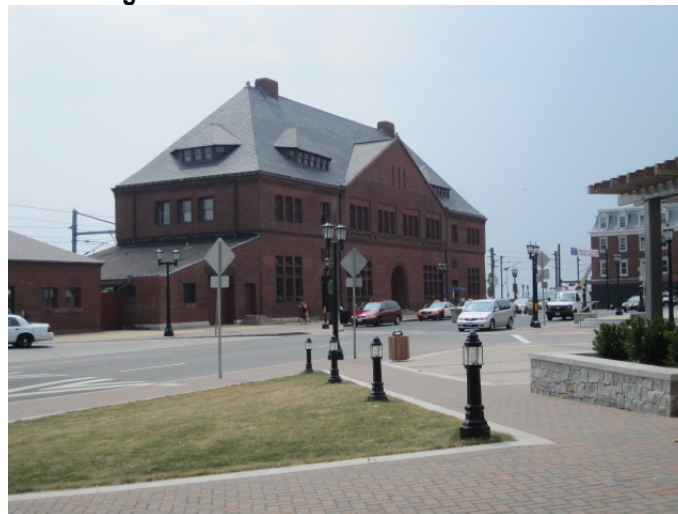
Figure 2-1: Union Station from Water Street

Union Station's façade is brick and matching brownstone. The original building was a rectangle in plan with its principal axis is a north-south line. Originally, it had three stories, with a two story major waiting room at the center of the first floor. Two additional levels were added at a later date, within the original envelope. A single story baggage room was added at the north end bringing the full length to around 184 feet. The Greyhound building was added at the north end of the baggage room. It is a truncated rectangle with its east wall parallel to the rail platform and the west wall parallel to Water Street. Figures 2-1 and 2-2 show Union Station and the Greyhound building.

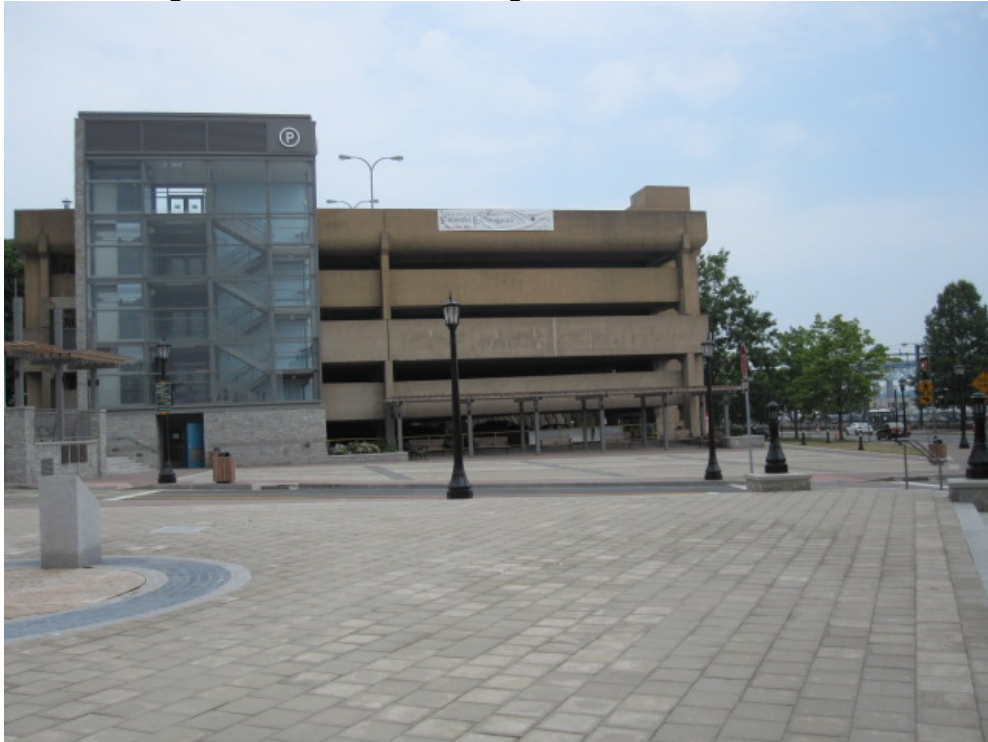
Figure 2-4: Water Street Garage as Seen from the Parade

The Water Street Garage is owned by the City of New London. The garage was built thirty years ago, and the two top levels added four or five year later. The exterior design is both structurally rational and well proportioned. The garage is by far the largest building in the area, yet by virtue of the façade treatment and some landscaping along Water Street and the Parade it adds to the urban scene rather than detracts from it. The Water Street Garage provides 906 parking spaces, serving railroad and ferry boat passengers. Figure 2-3 depicts the Water Street Garage.

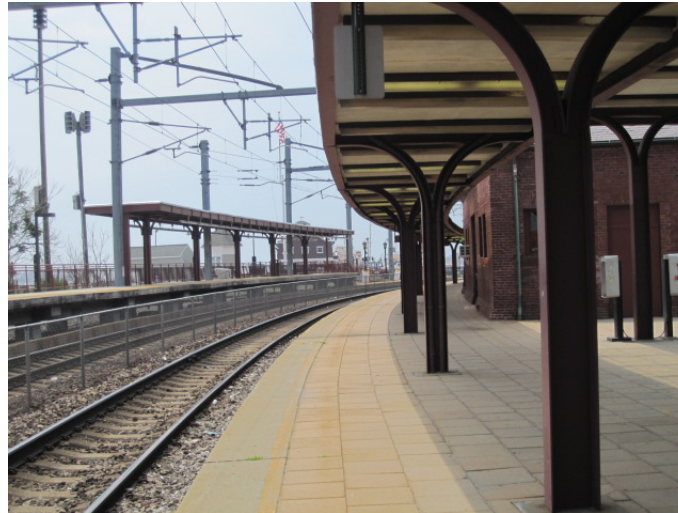
Figure 4-1: Showing Adjacent Platform for Track 1 and Elevated Platform for Track 2

trains since it is significantly more convenient to the station than track two. Track two is separated from track one and the platform for track one by a fence to keep people from crossing the tracks. The platform for tracks two and three is elevated. It is accessed from grade by an ADA accessible ramp at the south end of the platform. To reach that ramp a person in the station building must walk south about 150 feet to cross State Street. State Street connects the City to the waterfront and crosses the tracks at a signalized grade crossing. A passenger must use that grade-crossing to get from the station to the ramp for the north bound train. Figure 4-1 shows the back of Union Station and the platforms.

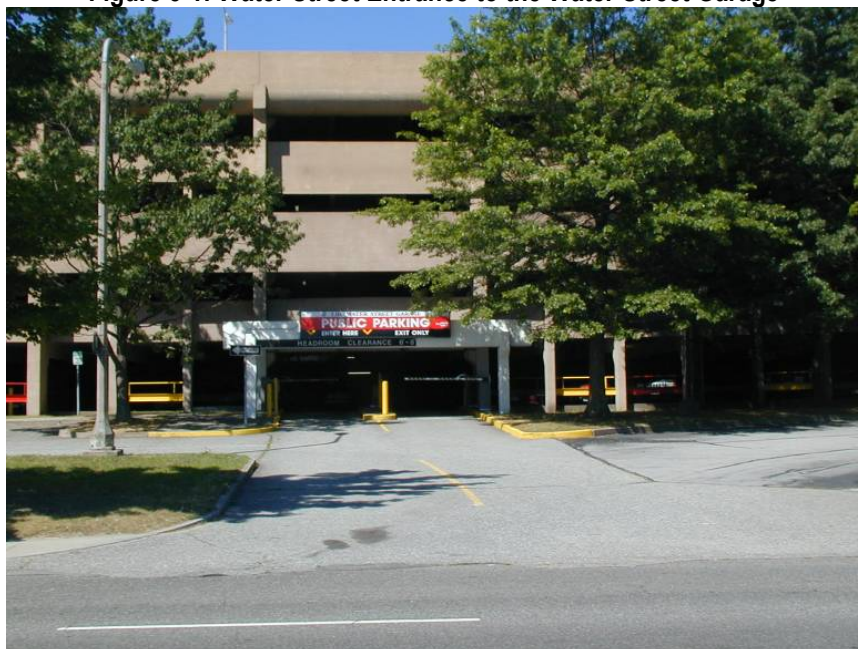
Figure 5-1: Water Street Entrance to the Water Street Garage

The Water Street Garage is owned by the City of New London. It provides 906 parking spaces, serving rail commuters, ferry boat passengers and people working in the general commercial areas along the streets leading to the Parade, Union Station, and the waterfront. The garage manager reported that the 906 spaces are completely filled on two summer weekends and relatively full on the other summer weekends. The garage is less than half full in the winter months. Figure 5-1 shows the Water Street Entrance of the garage.

The condition of the Water Street Garage was assessed by Desman Associates in 2001 and again in 2007.¹⁵ In the latter appraisal, a long list of repairs was required. Table 5-1 shows the recommended repairs, which totaled around \$1,533,288 as Priority I repairs, \$332,852 as Priority II, and \$685,500 as Priority III. The total cost of that work was projected to be \$2,551,640 in 2007 dollars. These costs did not include design or construction management fees, for which Desman recommended adding an additional 12 to 15 percent.
