**HAZARD MITIGATION PLAN UPDATE
ANNEX FOR THE TOWN OF NORTH STONINGTON**

**Southeastern Connecticut Council of Governments
Multi-Jurisdictional Hazard Mitigation Plan Update**

DECEMBER 2017

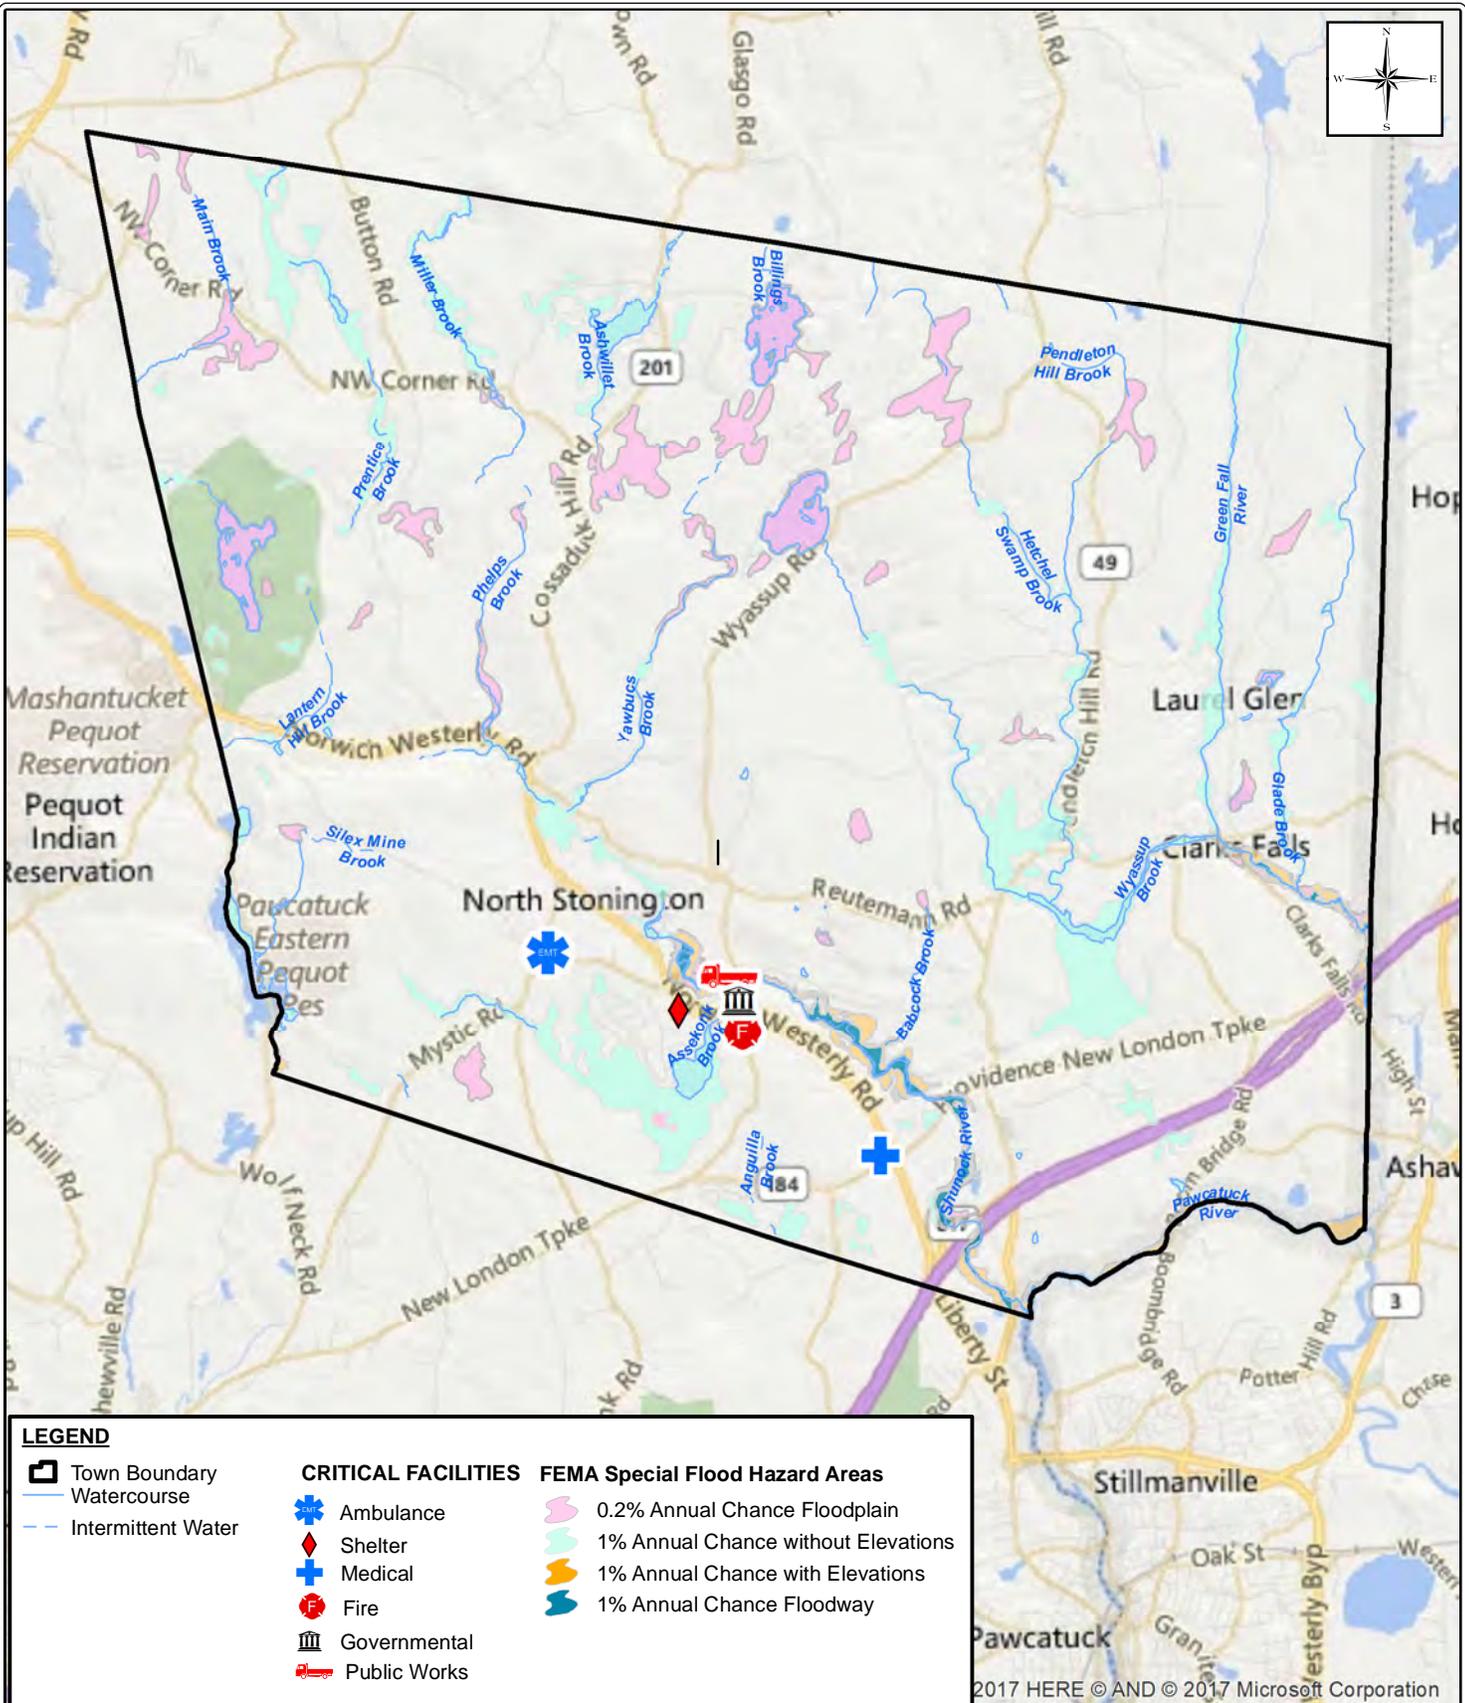
FEMA SPECIAL FLOOD HAZARD AREAS

SOURCE: NATIONAL FLOOD HAZARD LAYER, FEMA, 2017

Major inland watercourses and water bodies in North Stonington have the 1% annual chance floodplain defined by FEMA. The Pawcatuck River, the Shunock River, the Green Fall River, and Whitford Brook each have sections mapped as Zone AE indicating that flood elevations are available. The remaining streams are mapped as Zone A and include Ashwillet Brook, Assekonk Brook, Glade Brook, the upper reaches of the Green Fall River, Hetchel Swamp Brook, Lake of Isles Brook, Lantern Hill Brook, Miller Brook, Pendleton Hill Brook, Phelps Brook, Prentice Brook, the upper reaches of the Shunock River, Wyassup Brook, and Yawbucs Brook as well as several other unnamed streams, several ponds, and swamp areas. Refer to Figure 3-1 for the location of the 1% annual chance floodplains within North Stonington.

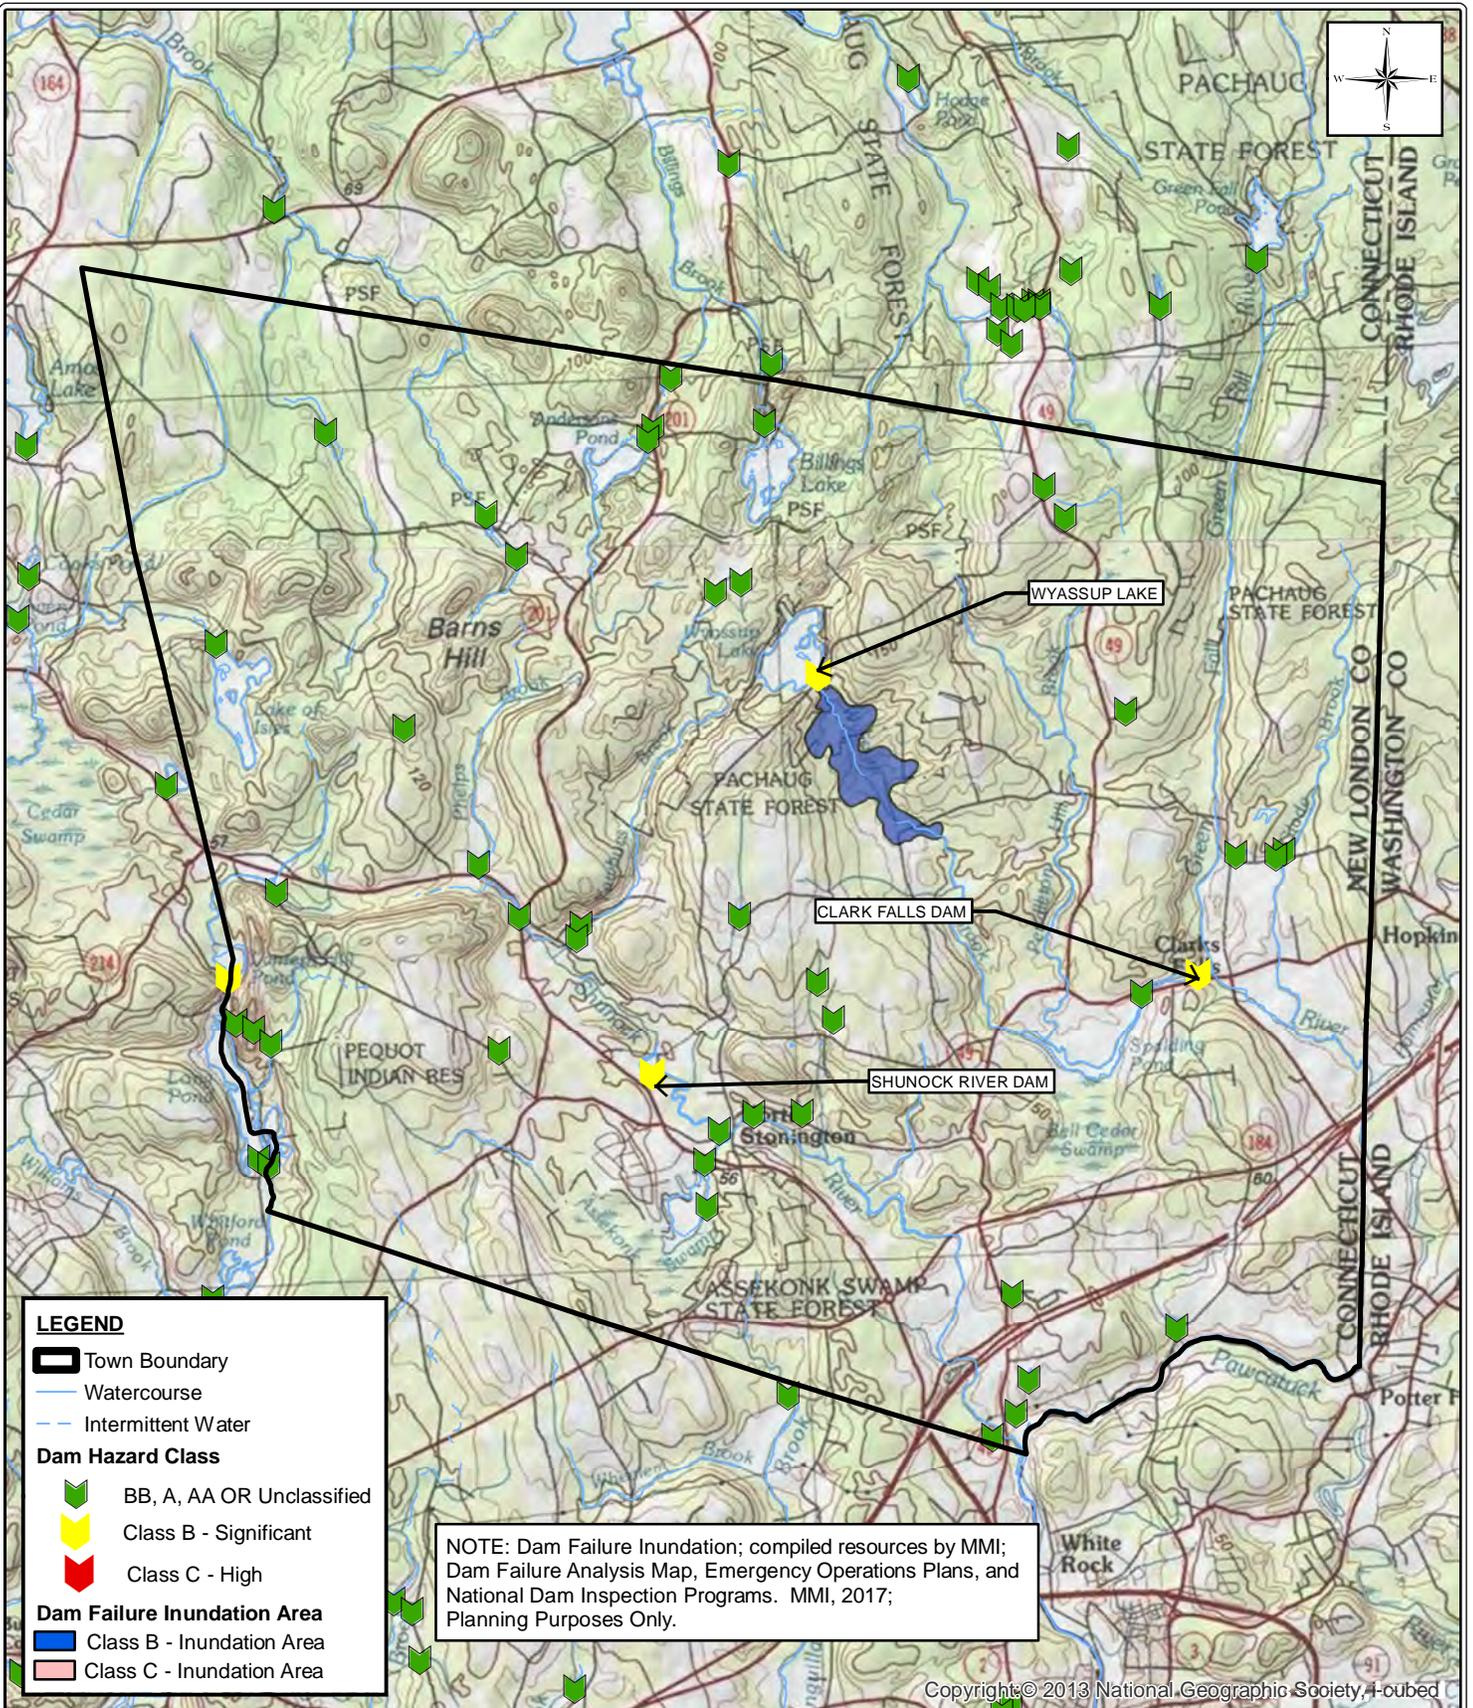
North Stonington is considered a low-risk area for dam failure since the significant hazard dams are maintained in coordination with the Connecticut DEEP, and very few structures are located in downstream in potential inundation areas. Potential mitigation measures for dam failure include a combination of prevention, education, and emergency planning, as well as dam removal projects as discussed in Section 11.
